TECHNICAL REPORT M-238  
May 1978

FRACTURE CHARACTERISTICS OF ASTM A-607  
PIPELINE STEEL, ASTM A-516 STRUCTURAL STEEL,  
AND ASTM B-209, ALUMINUM ALLOYS 5083 AND 6061

by  
J. K. Scott

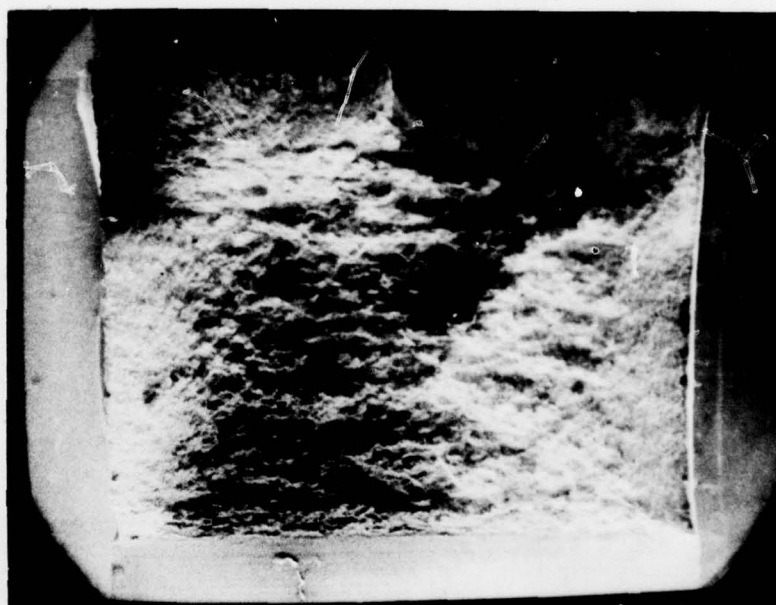
**Figure 47.** 5083 aluminum Charpy impact specimen tested at 25°C, 11X.

The aluminum 5083 Charpy impact specimens all failed in a ductile manner. The  $-196^{\circ}\text{C}$  specimen had a very slanted surface whose layers indicated tearing along the grain structure (Figure 45). This is the result of large amounts of second phases congregating in the grain boundaries as shown in the microstructure in Figure 7. At this low temperature, the failure propagates through the less cohesive grain boundaries. The remaining specimens have a fibrous appearance indicating some influence of grain boundary tearing (Figures 46, 47, and 48). Failure occurs primarily by dimple rupture, and the surfaces indicate increasing plastic deformation as demonstrated by increasing shear lip size.

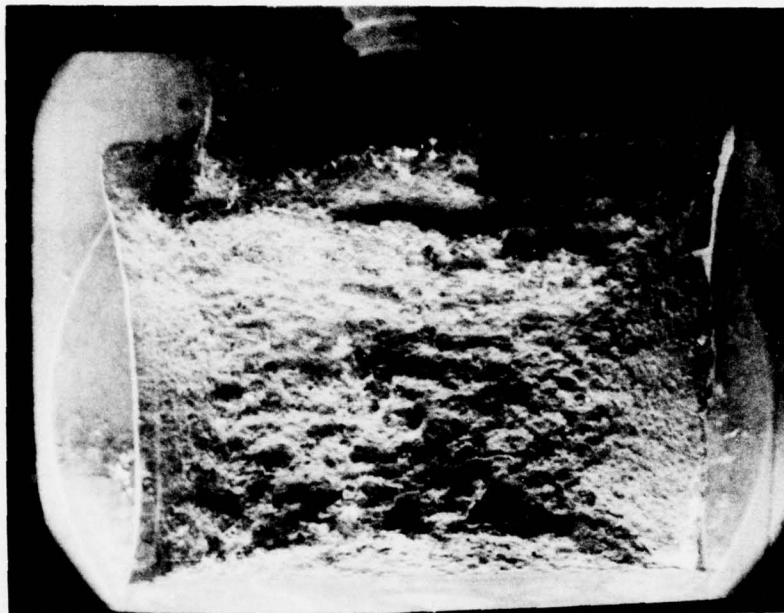
**Figure 48.** 5083 aluminum Charpy impact specimen tested at 100°C, 11X.

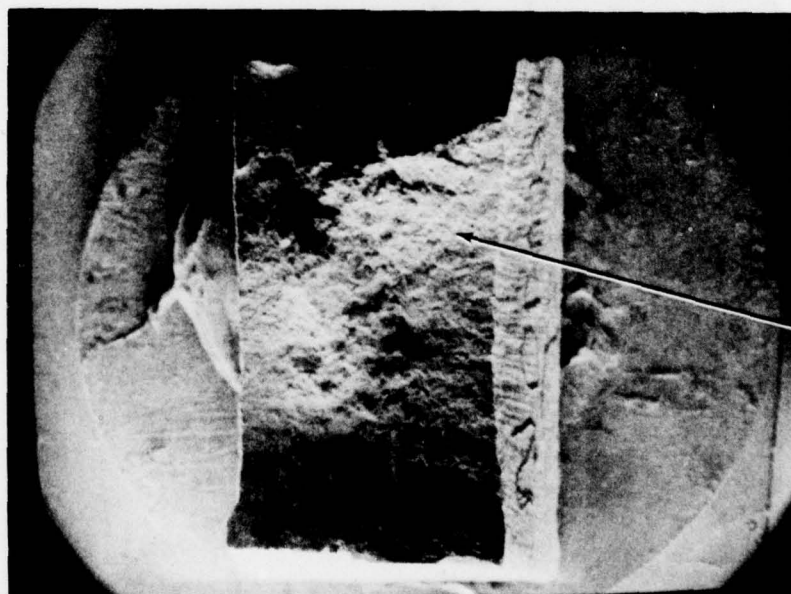
**Figure 49.** Tensile fracture surface of 6061 aluminum, 10X.

The fracture surface of the aluminum 6061 tensile specimen is shown in Figure 49. Failure occurred by inclusion-generated dimple rupture (Figure 50). Alloy 6061 is a precipitation-hardened aluminum in which precipitates tie up dislocations and improve the material's yield strength. The effects of the different sizes of precipitates (inclusions) are shown very clearly in this alloy. Very fine dimples are formed around small inclusions; large dimples are formed around large inclusions.

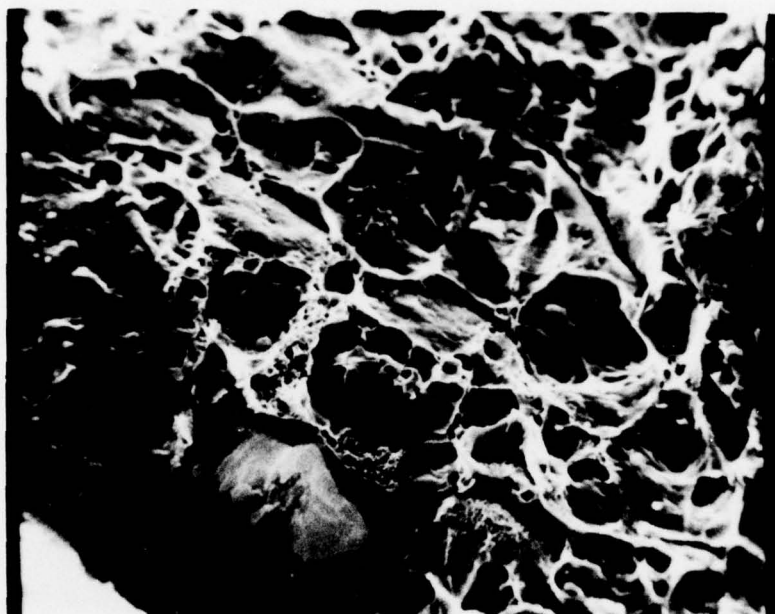
**Figure 50.** Dimple rupture in 6061 aluminum fracture surface, 300X.

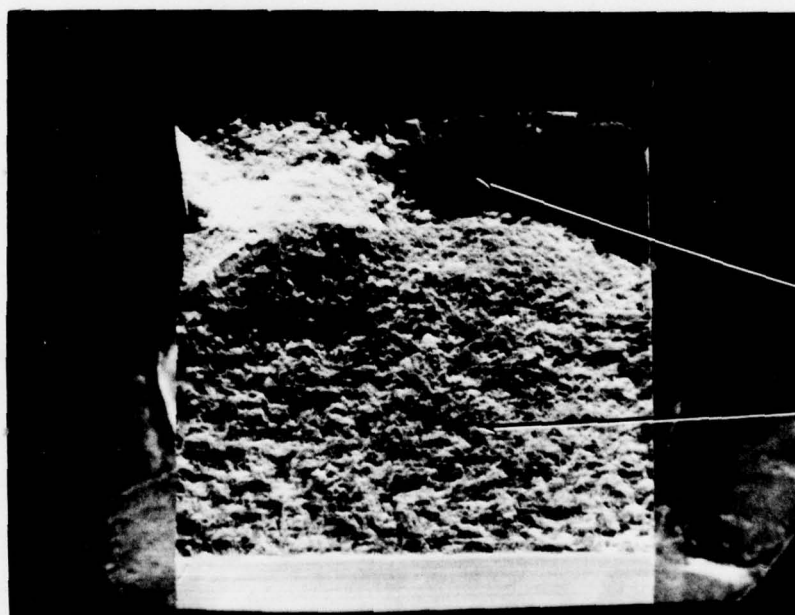
**Figure 51.** Fatigue fracture surface of 6061 aluminum, 13X.

The as-received aluminum 6061 fatigue specimen shows the typical tensile overload and fatigue regions (Figure 51). Failure occurred by inclusion-generated dimple rupture (Figure 52); the presence of both a fine and coarse dimple structure is also evident in this specimen. Failure in the fatigue region occurred by transgranular fracture, and areas of fatigue striae can be identified (Figure 53).

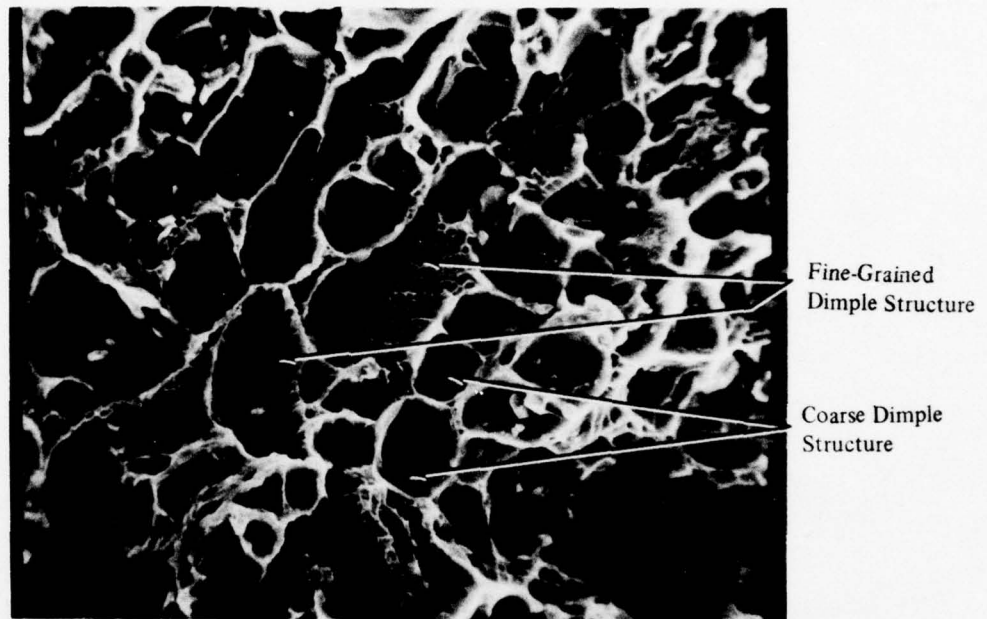
**Figure 52.** Dimple rupture in 6061 aluminum fatigue fracture surface, 300X.

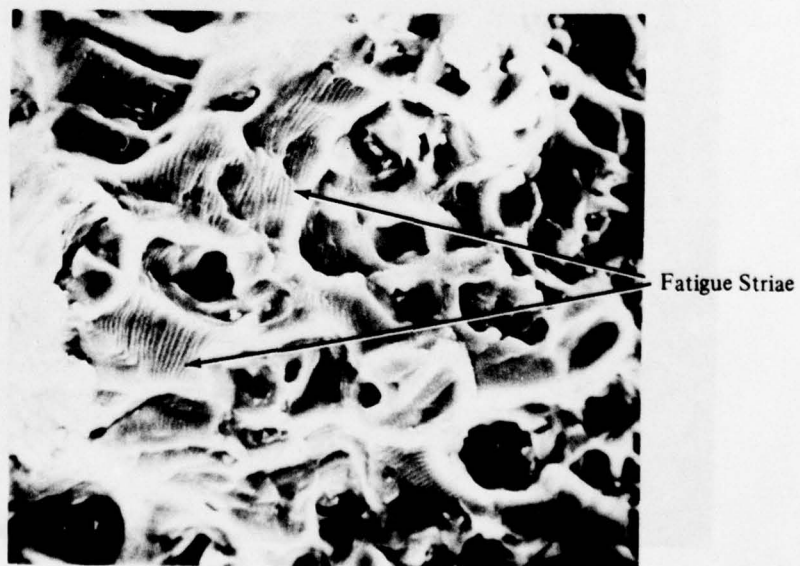
**Figure 53.** Fatigue striae in 6061 aluminum, 300X.

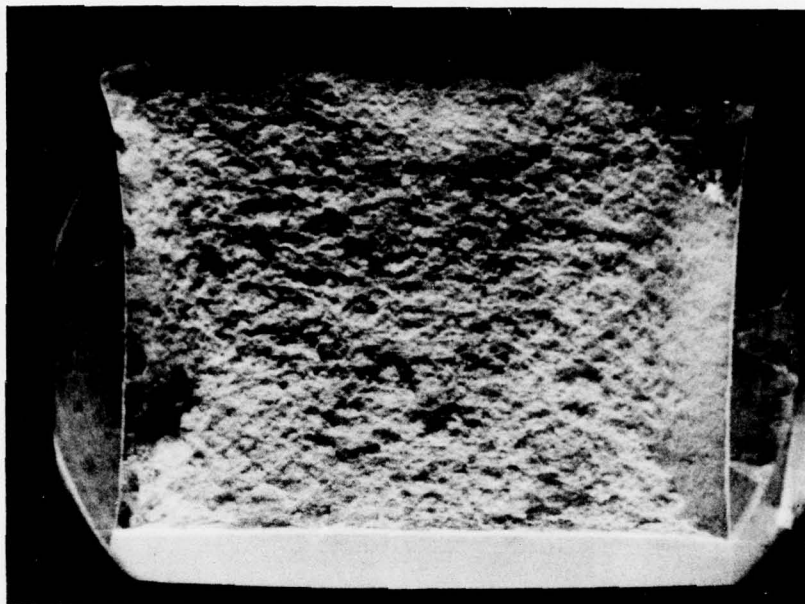
**Figure 54.** 6061 aluminum Charpy impact specimen tested at  $-196^{\circ}\text{C}$ , 11X.

Failure occurred by dimple rupture in the as-received aluminum 6061 Charpy impact specimens tested at all temperatures (Figures 54 through 58). An increase in plastic deformation was evidenced by increasingly prominent shear lips with increasing testing temperature. However, in contrast to steel, and on the basis of absorbed energies, these alloys do not develop a ductile-to-brittle transition.

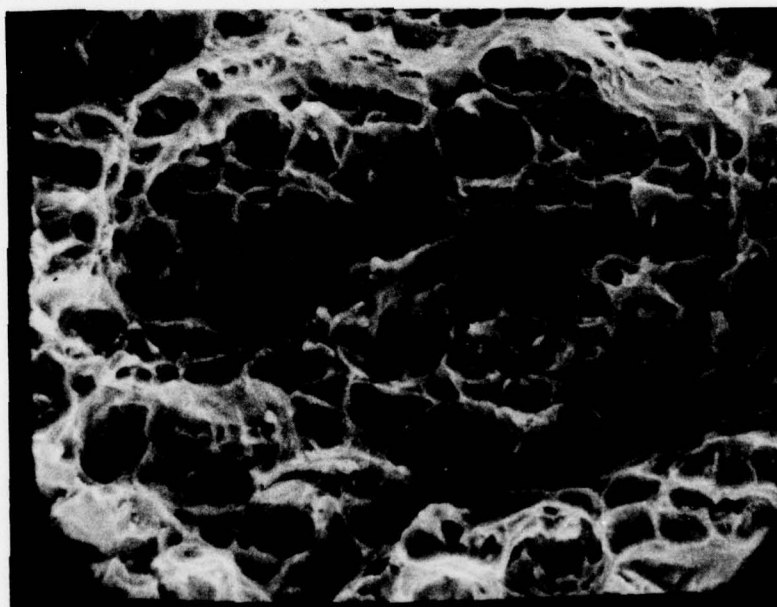
**Figure 55.** Dimple rupture in 6061 aluminum Charpy impact specimen tested at  $-196^{\circ}\text{C}$ , 550X.

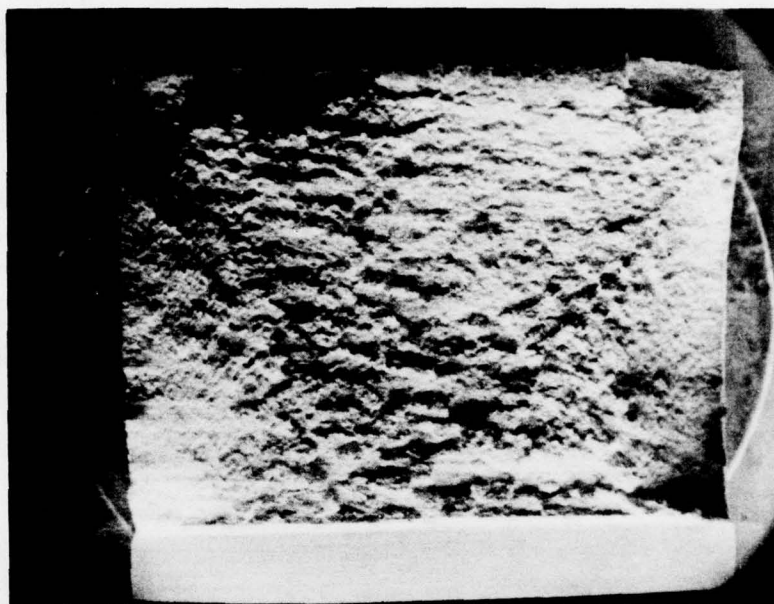
**Figure 56.** 6061 aluminum Charpy impact specimen tested at 0°C, 10X.

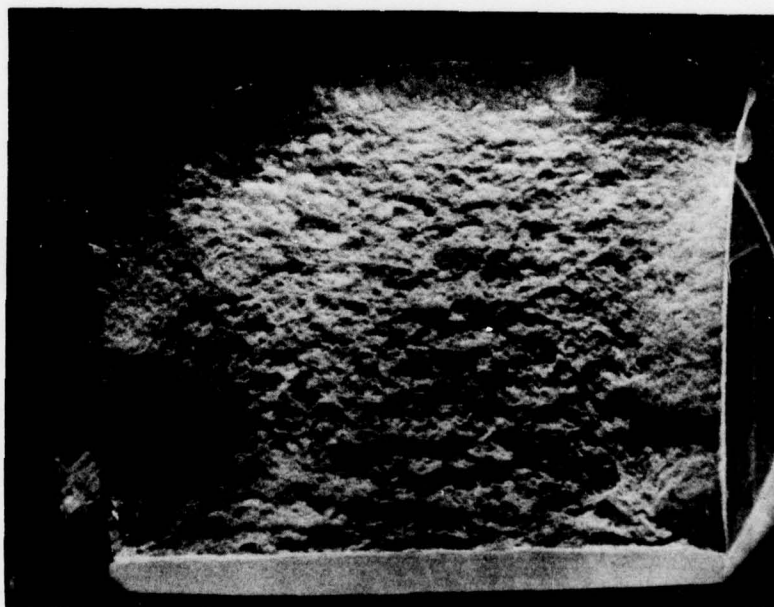
**Figure 57.** 6061 aluminum Charpy impact specimen tested at 25°C, 11X.

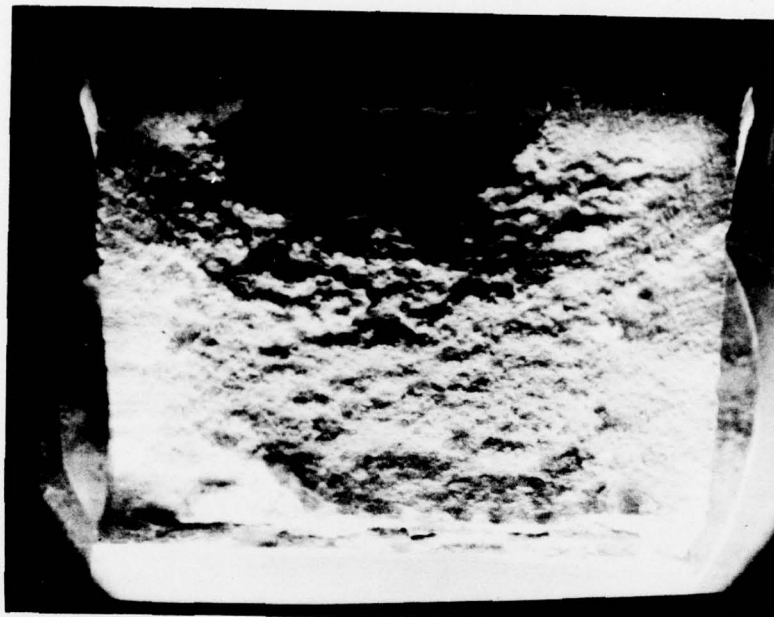
Figure 58. 6061 aluminum Charpy impact specimen tested at 100°C, 11X.
